HISTORIC STRUCTURE REPORT

THE PARSON CAPEN HOUSE

The Topsfield Historical Society
Topsfield, Massachusetts

APRIL 1 2002

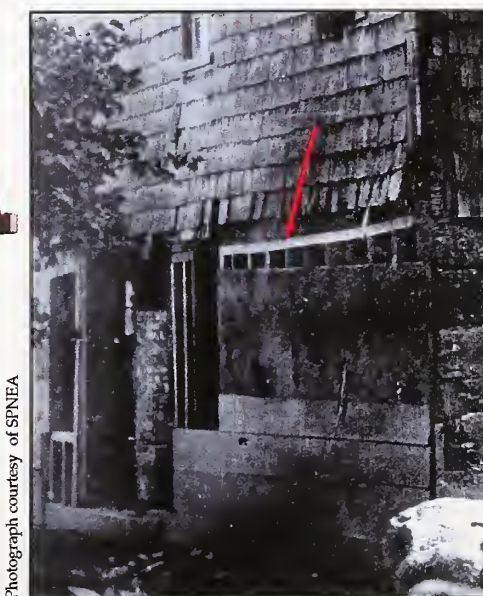
18.4: Northwest corner in 1913 showing new header (arrow) placed under rear girt with all new studs below. Dow completely replaced all early framing in the north wall with conventional new framing except the principal posts, which he ended out at the bottom. The extensive distortion still present in the rear wall appears to predate Dow's repairs, which secured the wall in its current state.

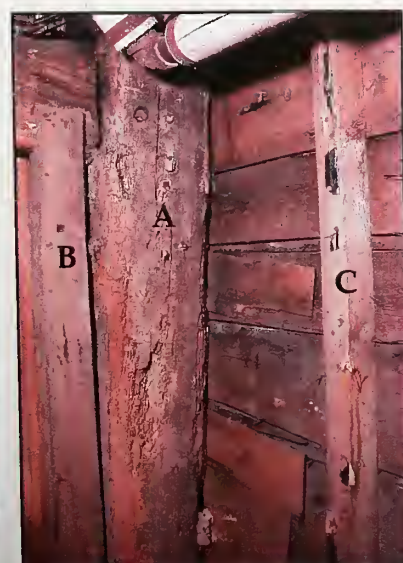
18.3: Chimney post (A) exhibits considerable old insect damage that had been concealed behind insulation for years. Framing should be left accessible whenever possible to facilitate routine monitoring to catch future deterioration problems in easterly stages. The bottom 2' of this post was replaced by Dow. The door stud to the left (B) is an early stud reused by Dow indicating he did not always use new wood, although in this case wire nails were used. The stud on the right (C) is one of Dow's replacement wall studs.

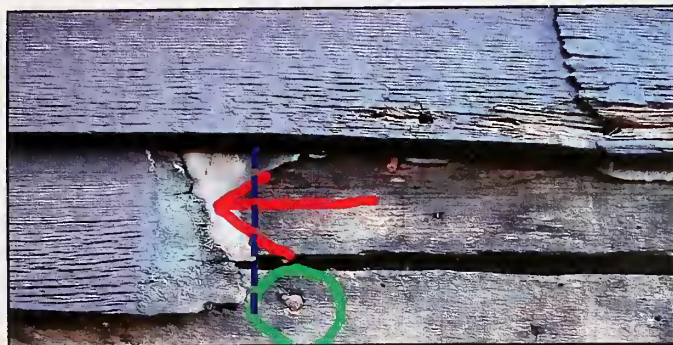
19.1: The bevel on the end of the Dow's clapboards was cut on a table saw rather than being skived with a draw knife. Because of the taper of the clapboard thickness, the resulting bevel edge indicated by the red arrow is angled rather than straight making the overlap of the clapboards ends minimal. When done with a drawknife the bevel is uniformly about 2" wide (the blue line indicates where the bevel edge should be), making a more watertight overlap.

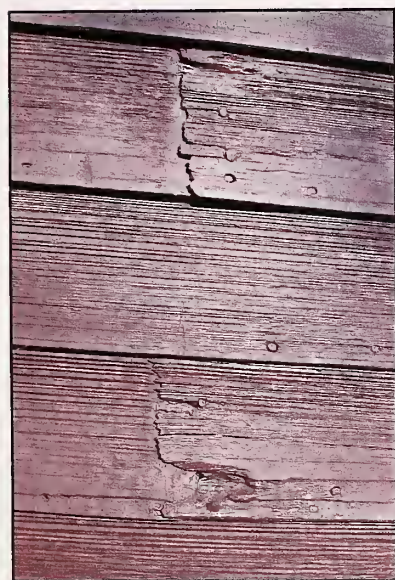
19.2: Many clapboards have splits and small missing pieces at their ends. In some cases these gaps were filled with epoxy in the 1975 work, making selective replacement more difficult.

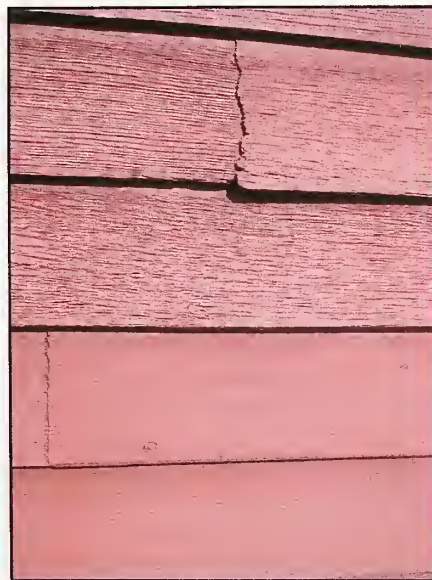
19.3: Since the 1950's red cedar has been used for replacement clapboards rather than matching Dow's white oak. These have a much smoother texture than the oak. The ones installed since the 1970's are especially obvious because the application of paint since then has prevented any weathering.

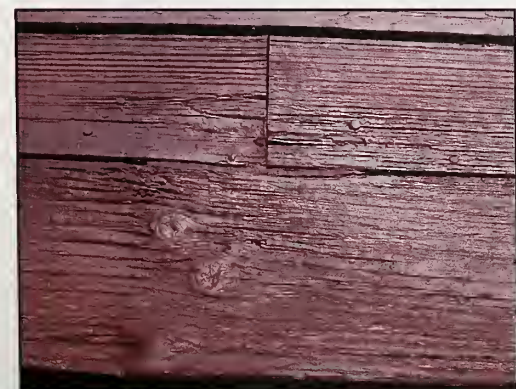
19.5: Another example of deeply weathered clapboards and trim from the south facade at the overhanging girt.

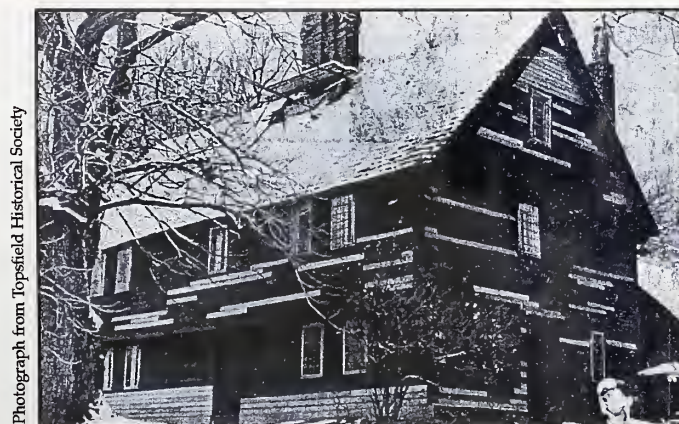
19.6: Newspaper photograph from 1975 showing the amount of clapboard replacement done in the 1975 work using red cedar rather than white oak. These clapboards are still visually obvious as shown in 19.3 above. Close examination reveals that quite a few other clapboards have been replaced over the years.

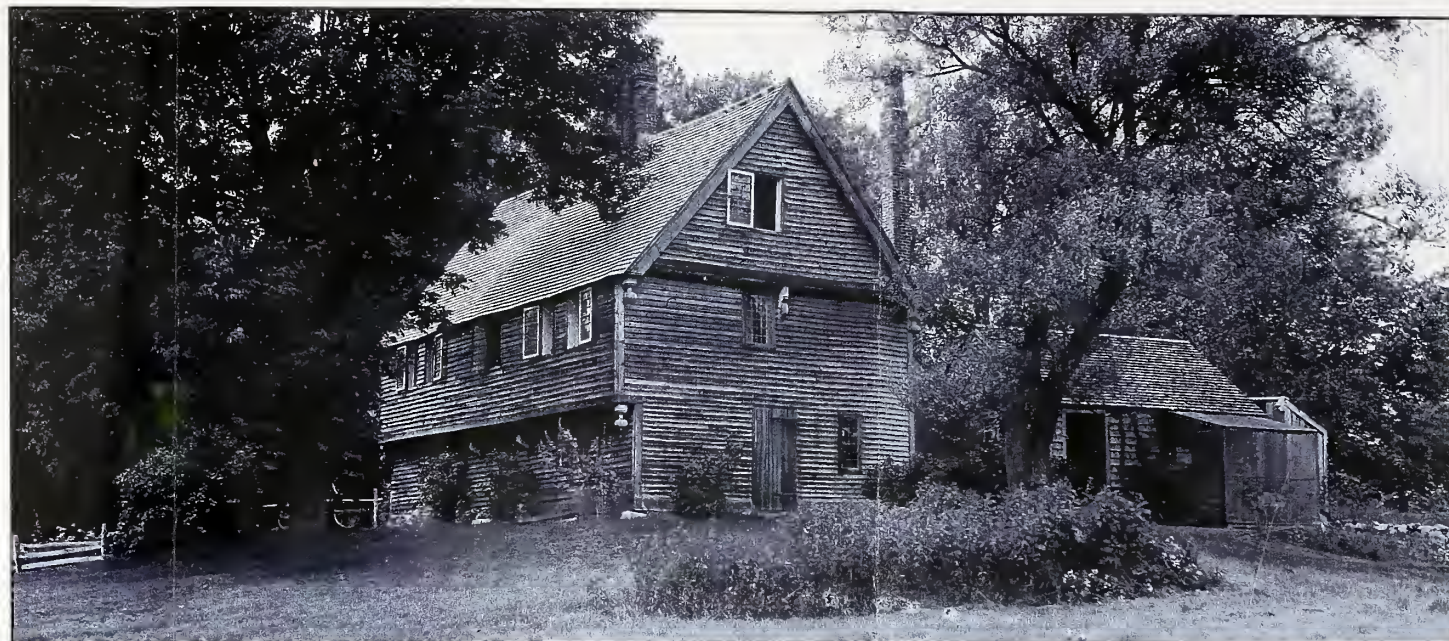
19.4: 1936 Historic American Building Survey (HABS) photo showing the house after it had been weathering without paint for 23 years as Dow intended it to be presented. The rear shed that was replaced in 1974 is also shown along with the furnace chimney as a tall brick stack. It was reduced in height and covered with clapboards in 1999. 19.7 below shows a close up of the weathered clapboards and trim. 1.2 shows the same view in color during the 1960's with some of the warped clapboards having been replaced, but still left to weather naturally.

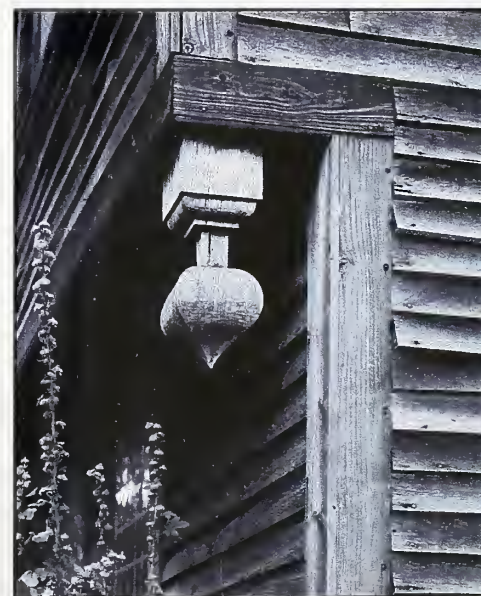
19.7: 1936 HABS photo of the southeast corner showing the tendency of Dow's clapboards to warp when left to weather without paint. This illustrates the maintenance trade off in following Dow's interpretation of leaving the exterior without paint. Going back to an unpainted exterior will be true to Dow's intention, but require more frequent clapboard and trim replacement.

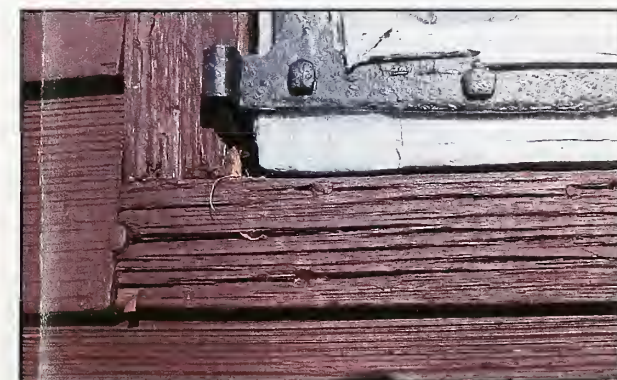
19.8: Window frame trim on many windows is deeply split and requires replacement. This trim seems to be only about 1/2" thick, making replacement simple as long as there is not deeper deterioration. In some cases the pintles are broken or the wood they are seated in is rotted making the sash loose and likely to fall out if opened. The window frames appear to be made of 1" thick stock (i.e., 5/4), but their relationship to the sheathing and other construction details are not known.

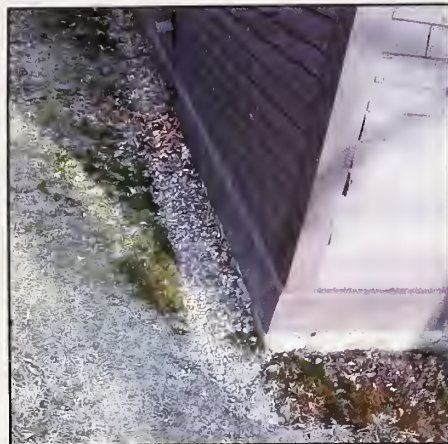
20.1: Northwest corner showing moss growth from chronic dampness and the grade sloping into the narrow gravel drainage channel at along the rear foundation. Note that sill and water table are nearly at grade. Substantial regrading and a French drain should be considered to better divert water away from the rear foundation.

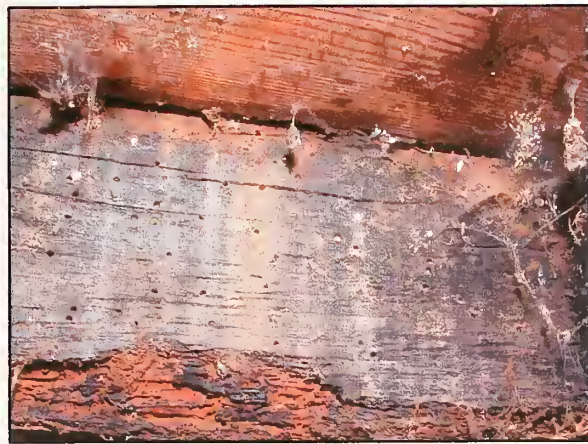
20.2: Sill at front of parlor basement and chimney girt show some light colored frass and exist holes indicating possible active insect infestation (probably powder post) as well as long past activity. Limited testing with a drill did not find deep deterioration.

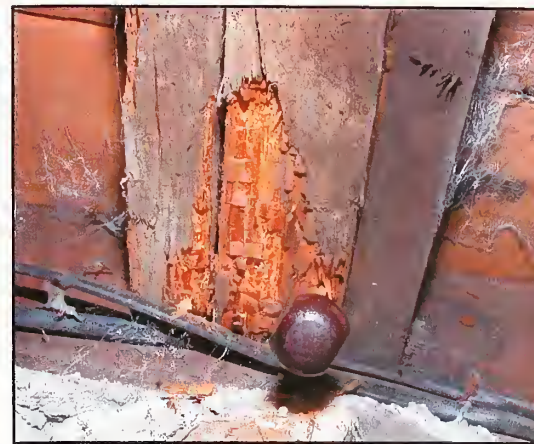
20.3: A few of the hall cellar joists exhibit modest rot at the north sill. The damage was shallow, but should be monitored for progressive damage along with reducing the moisture problems along the north foundation.

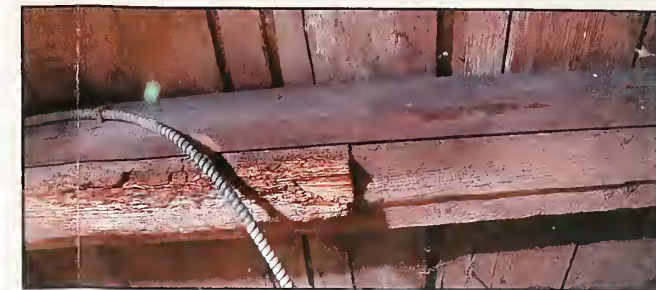
20.4: All the hall cellar joists have had their ends replaced with sisters added to reinforce the splice about 4' from the north wall (circle marked "A" on plan 20.6), probably by Dow in 1913. Rot damage to the old joist predates the repair. The subfloor was also replaced. Most of these splices are hidden by boarding over the furnace area.

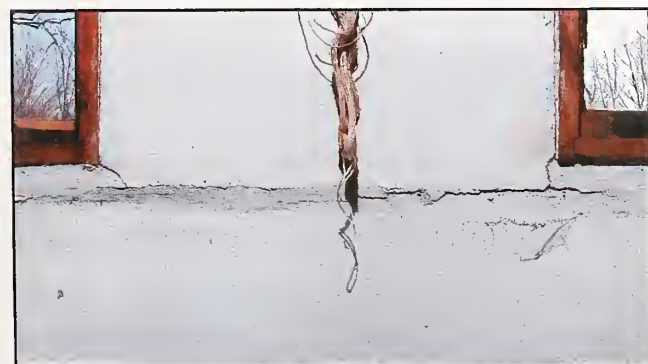
20.5: Buckled plaster between the front windows of the parlor. Wayne King suggests this is related to the plaster substrate and previous plaster repairs rather than structural problems in the sill below. When the wall is opened up to repair the plaster the cause can be determined.

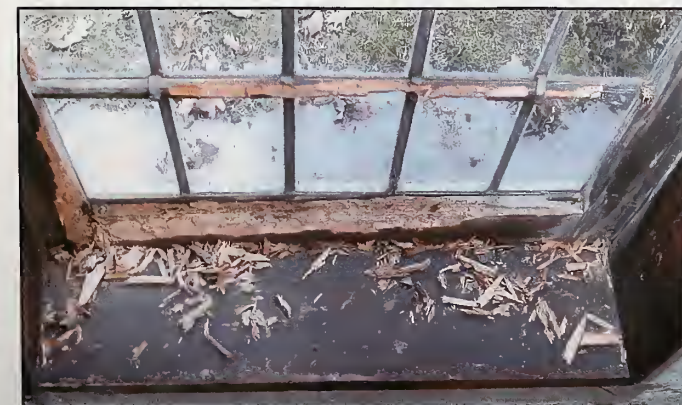
20.9: Window in north wall of parlor showing fresh damage from a squirrel getting into the house. Other windows show similar damage from past squirrel episodes. There is no screening on the chimney top to prevent squirrels from getting in through the open fireplace flues. Stainless steel hardware cloth should be installed unobtrusively on the chimney top as soon as possible.

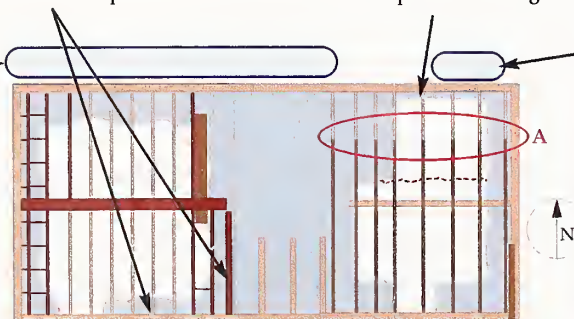
20.6: Plan of cellar.

NOTE: Most framing in cellar has been sistered and exhibits varying amounts of past deterioration due to chronic dampness. Debris should be cleaned out, ventilation improved, and conditions routinely monitored.

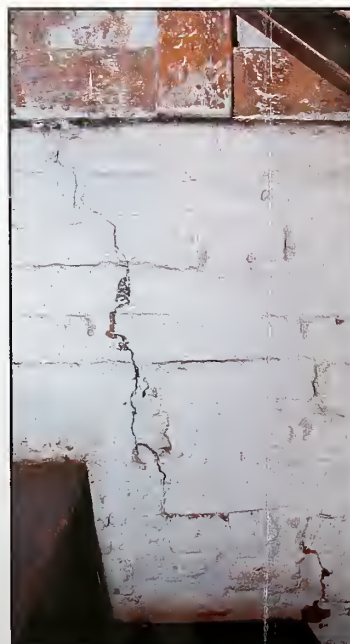
20.10: Crack in chimney stack and minor brick spalling at the stairs. These defects, which are a function of the relatively low strength first period bricks, are benign as long as no dramatic increase is observed. The spalling is a function of dampness rising in the masonry from the basement and soil below. Repairing the masonry with stronger bricks and modern cement mortar (or even lime as the original is clay) is likely to cause further cracking rather than alleviate it.

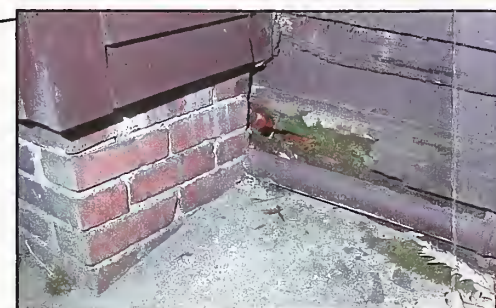
20.7: Roof drainage is trapped along the rear sill by the grading and the rear furnace flue enclosure causing substantial rot to the sheathing and possibly the sill. Note the moss growing on the water table.

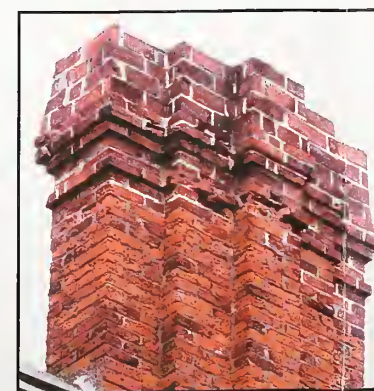
20.11: Chimney has a substantial number of loose and/or deeply spalled bricks and defective mortar joints; a few could fall out and pose a potential safety hazard. Repairs were last done in 1975. The spalling in the lower section is due to excessively soft old bricks being used by Dow in hard mortar, and cannot be effectively stopped.

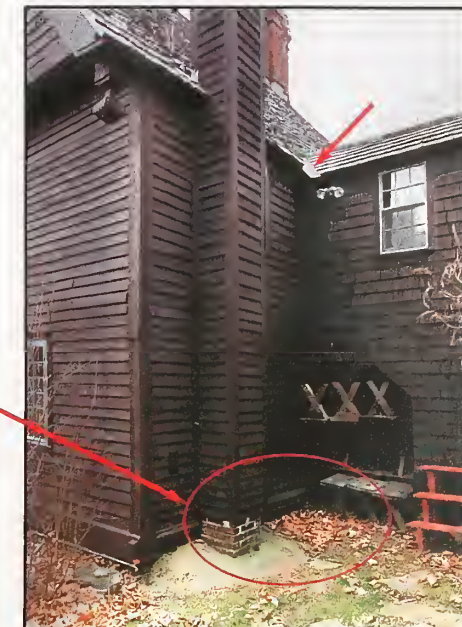
20.8: Northeast corner, stack for furnace flue, and link to 1964 ell. The combination of the short valley on the link roof (arrow) and the flue stack concentrates considerable roof runoff on foundation below. The resulting dampness lingers due both to the grading and the lack of sunlight on the north facade. There is a long history chronic deterioration in this area which the damage shown in 20.6 and 20.2 demonstrates to be ongoing. Plans to reconfigure the ell should include measures to reduce the dampness in this area, perhaps including removal of the furnace flue.
